## **MEMORANDUM**

**SUBJECT:** Investigation of Muldoon Grazing Association Property

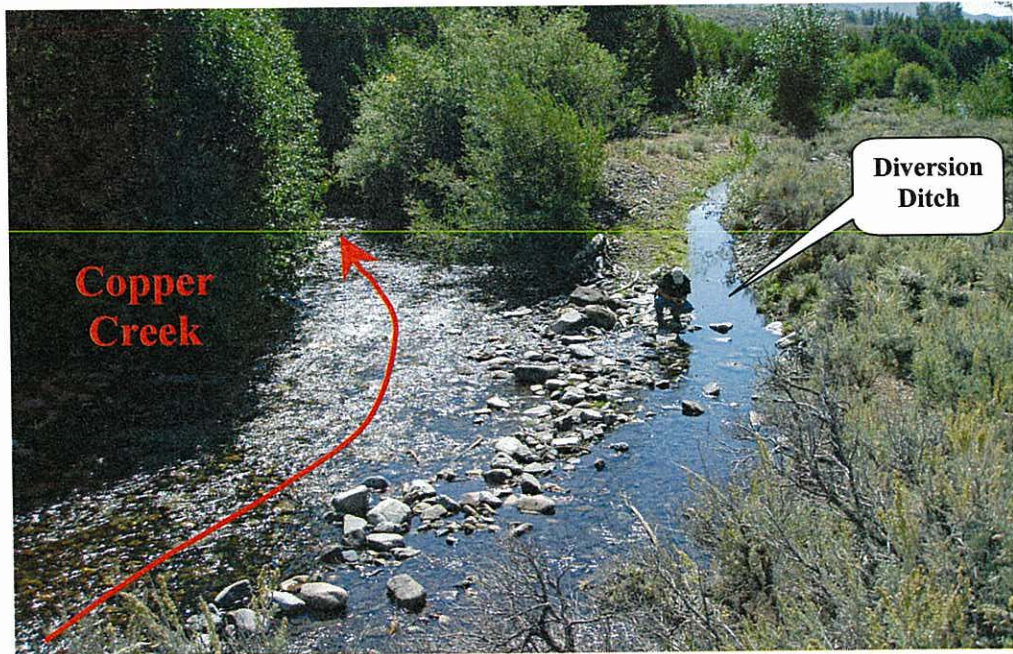
**ABOVE:** View on 9/6/2007 looking down Copper Creek showing the diversion ditch within the NWSE of Section 23 (T03N, R21E). The GPS coordinates for this location are 2506504, 1375080 (IDTM coordinates NAD83 projection). An estimate of the flow in this ditch was made using the “orange peel method” by timing a floating stick through a known length and average cross section for that length. The velocity through a 10-foot section of this ditch was 0.53 feet per second (19 seconds for a floating stick to travel the 10 measured feet). The average cross section was 0.44 square feet (32 inches wide x 2 inches deep). Since flow equals velocity multiplied by area, the flow through this ditch could have been as much as 0.23 cfs. ( $0.53 \times 0.44$ ). However, since the water flows the fastest at the surface and the middle of the ditch, the 0.23 cfs estimate is probably high. Using a standard reduction factor of 60% – 80% indicates that the **flow in this ditch was probably in the neighborhood of 0.14 cfs – 0.18 cfs.**

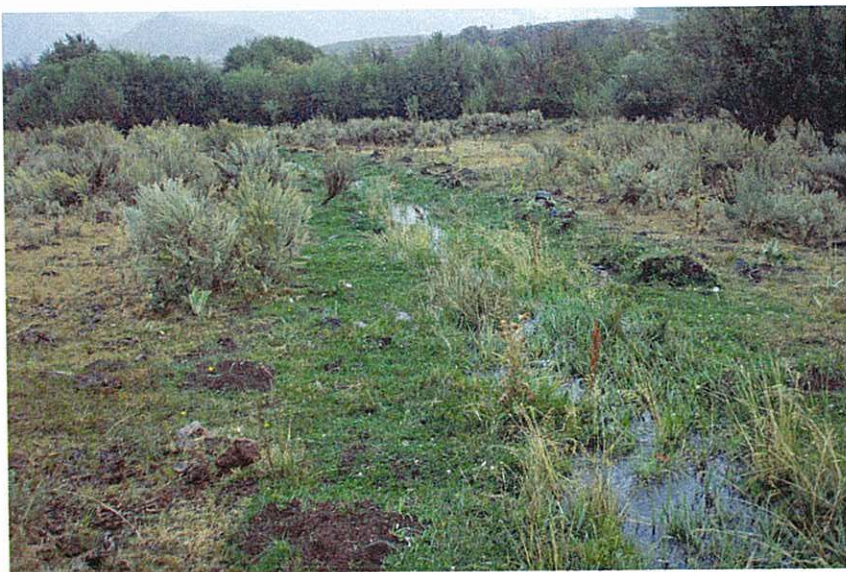
**LEFT:** View on 9/5/2007 looking up the diversion ditch shown in view above, only further downstream. Note the piles of earth along the ditch that have been excavated from the ditch.

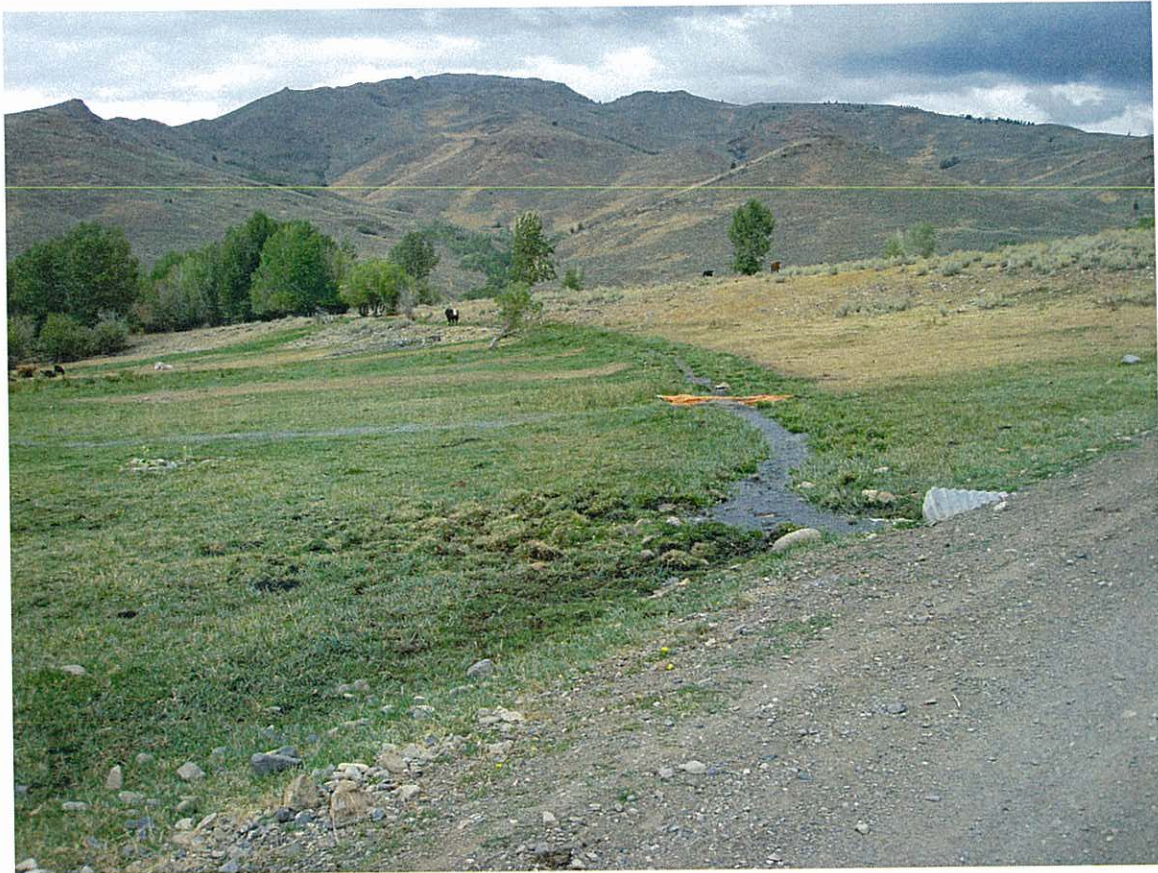
**ABOVE:** View on 9/6/2007 looking down the ditch running through the NENE of Section 26 (T03N, R21E) crossing the Muldoon Creek Road, just north of Muldoon Creek. This particular ditch collects water from a marshy area north of Muldoon Creek within the NENE of Section 26 and the NWNW of Section 25 (T03N, R21E). Irrigation of Guy Peterson's property may contribute to this marshy area located down gradient of his property. Examination of this marshy area did not reveal an obvious direct surface connection with Muldoon Creek. An estimate of the flow in this ditch was made using the "orange peel method" by timing a floating stick through a known length and average cross section for that length. The velocity through a 10-foot section of this ditch was 2.0 feet per second (5 seconds for a floating stick to travel the 10 measured feet). The average cross section was 0.83 square feet (2.0 feet wide x 5 inches deep). Since flow equals velocity multiplied by area, the flow through this ditch could have been as much as 1.67 cfs. ( $2.0 \times 0.83$ ). However, since the water flows the fastest at the surface and the middle of the ditch, the 0.23 cfs estimate is probably high. Using a standard reduction factor of 60% – 80% indicates that the **flow in this ditch was probably in the neighborhood of 1.0 cfs – 1.34 cfs**. Note the orange canvas dam diverting water from the ditch for irrigation of the surrounding area. This land is part of the place of use of SRBA recommendation 37-11418 that allows for the use of wastewater diverted from a different location. It appears that there is no water right that allows for the water diversion (ditch) shown in the view above.
